Manhole Inspection Summary

Manhole # S17OO1008MH

Insp Date: **12/15/06 9:28 AM**

Location Address: **4891 CLOVE TERR**

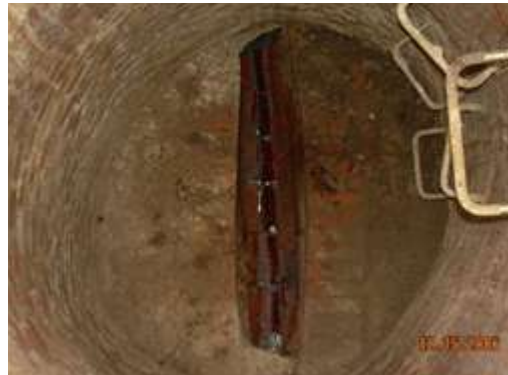
Top View

Bench debris.

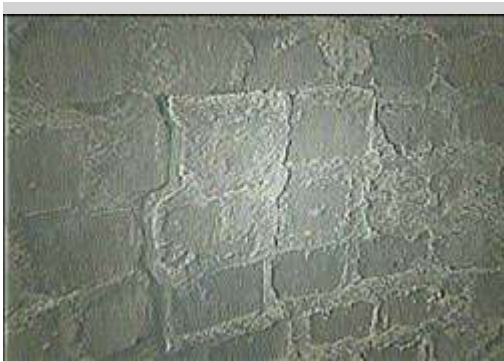
Defect

Condition: ☐ Sound ☒ **Cracked** ☐ Root Intrusion ☐ Loose Brick ☐ Deteriorated

Infiltration: ☐ None ☐ Joint ☒ **Cracks** ☒ **Mortar** ☐ Roots ☒ **Wall**

Barrel cracks and infiltration.

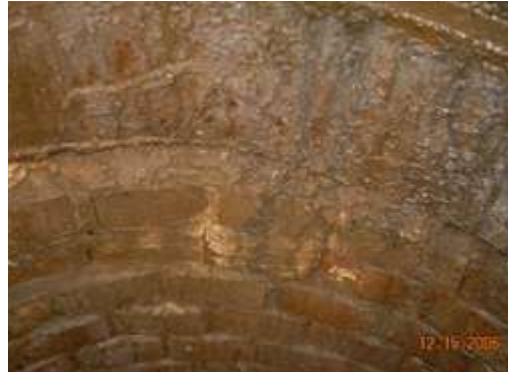
Defect

Frame Offset: **0** (in.) Condition: ☐ Sound ☐ Cracked ☒ **Leaks**

Condition: ☐ Sound ☐ Cracked ☐ Root Intrusion ☐ Loose Brick ☒ **Deteriorated**

Infiltration: ☐ None ☒ **Joint** ☐ Cracks ☒ **Mortar** ☐ Roots ☐ Wall

Frame leaks. Frame offset. Adjustment deterioration and infiltration.

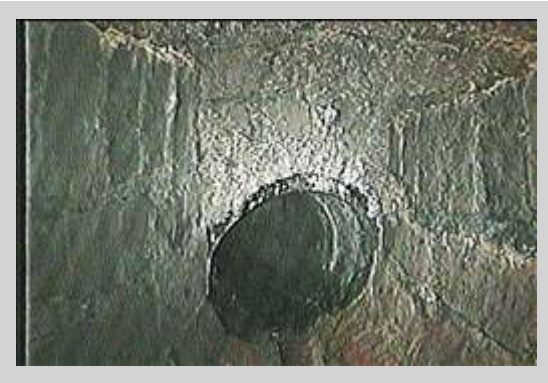
8 in. Circular Gravity Sewer Pipe Out @ 12 O'Clock

Channel deterioration.

Infiltration: **Evidence** Pipe Seal Cond: **Unknown**
